# Assessment of Dam Safety

## Coal Combustion Surface Impoundments (Task 3)

American Electric Power

Big Sandy  
Generating Station

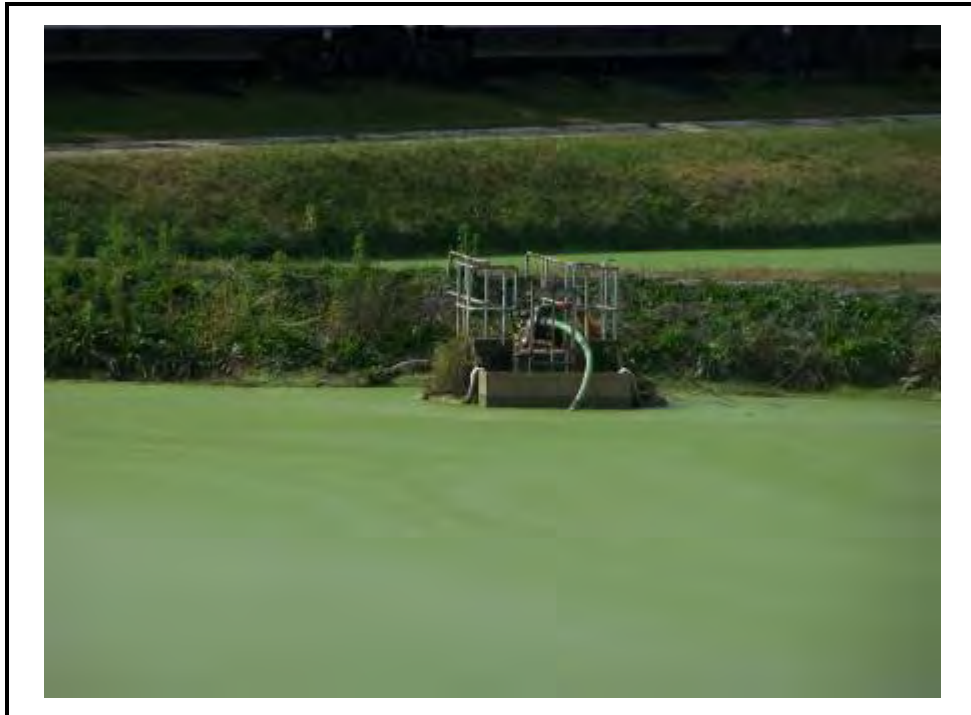
53

Decant structure from south Clearwater Pond to the Reclaim Pond.

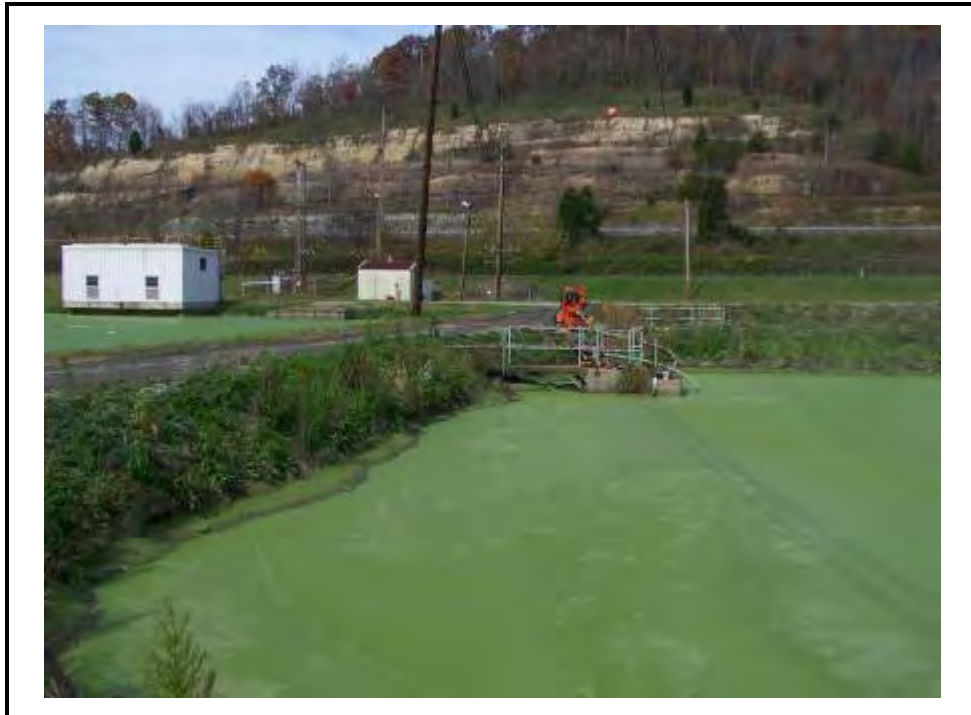
54

Splitter Dike between south Clearwater Pond (right side of photo)  
and the Reclaim Pond (upper left of photo).

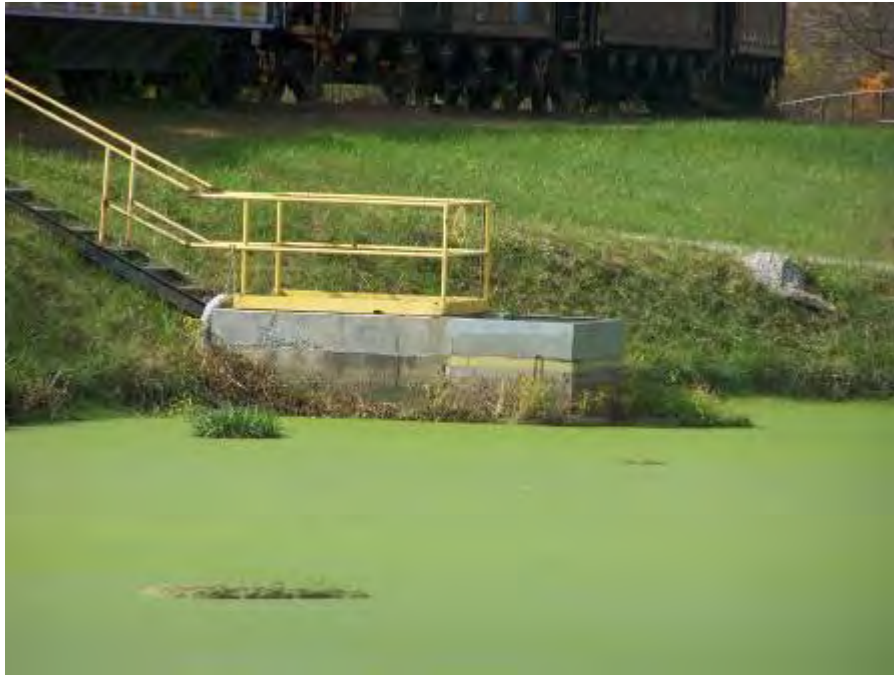
57

Close-up of non-permitted overflow to the Big Sandy River. Plant Personnel indicated that when water level reaches yellow line on the structure, pumping is initiated to Horseford Reservoir to prevent discharge to the river.

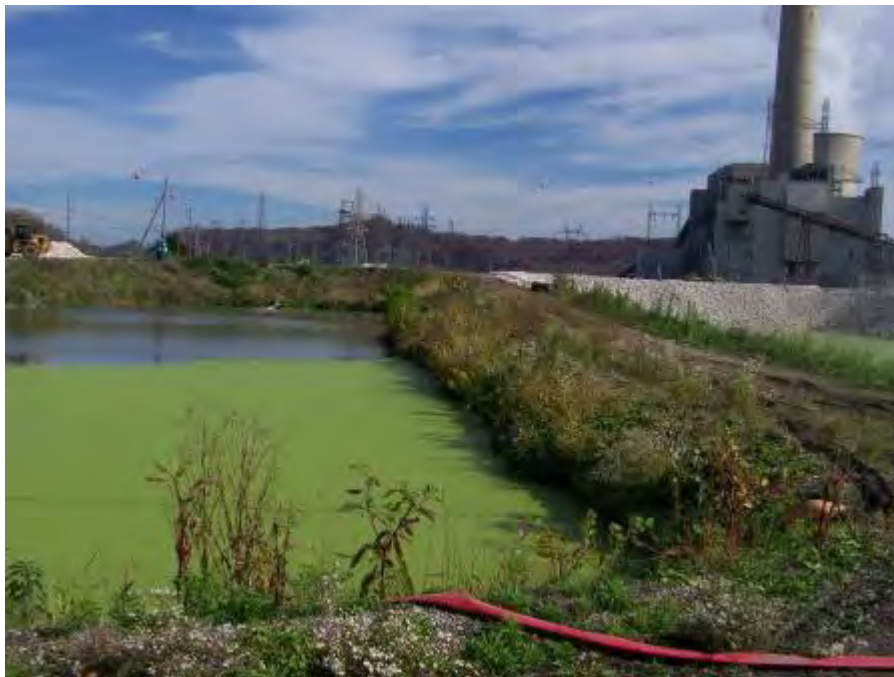
58

North side of Splitter Dike between north and south Clearwater Ponds, looking east.

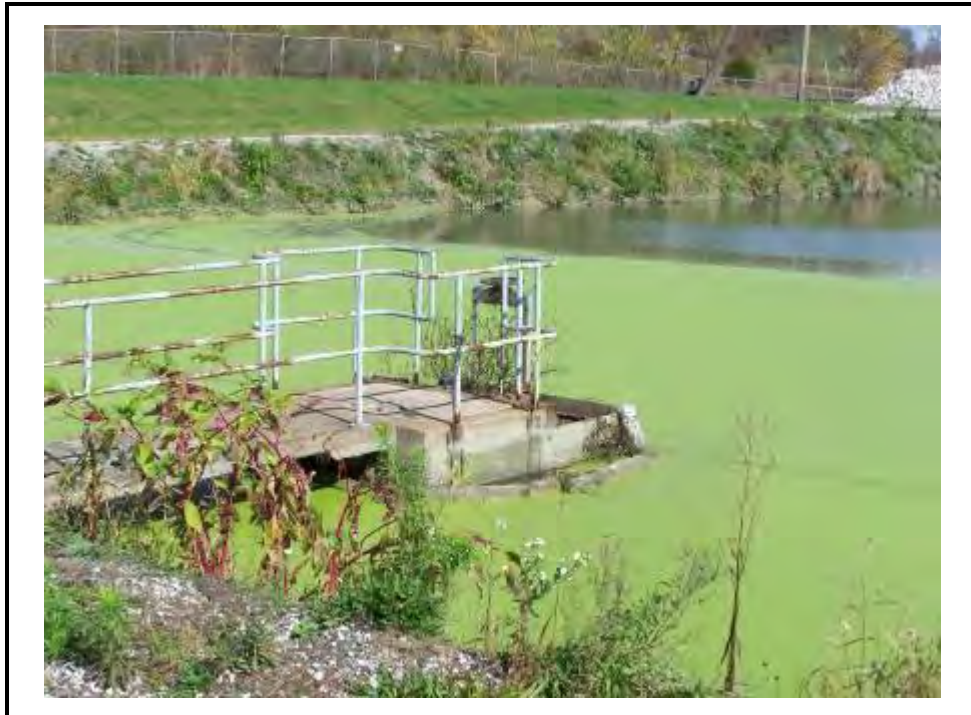
59

Discharge structure from north Clearwater Pond to Reclaim Pond  
and upstream slope of North Dike of Bottom Ash Complex.  
Note crest of North Dike slopes down to the west.

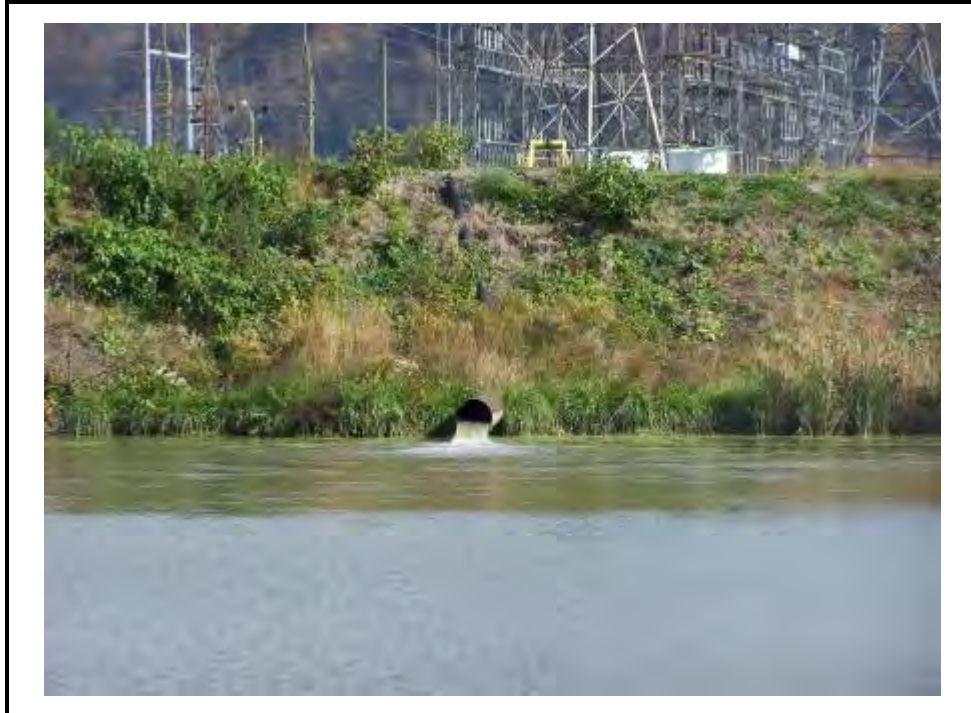
61

West slope of Splitter Dike between North Bottom Ash and Clearwater Ponds showing discharge pipe from North Bottom Ash Pond.

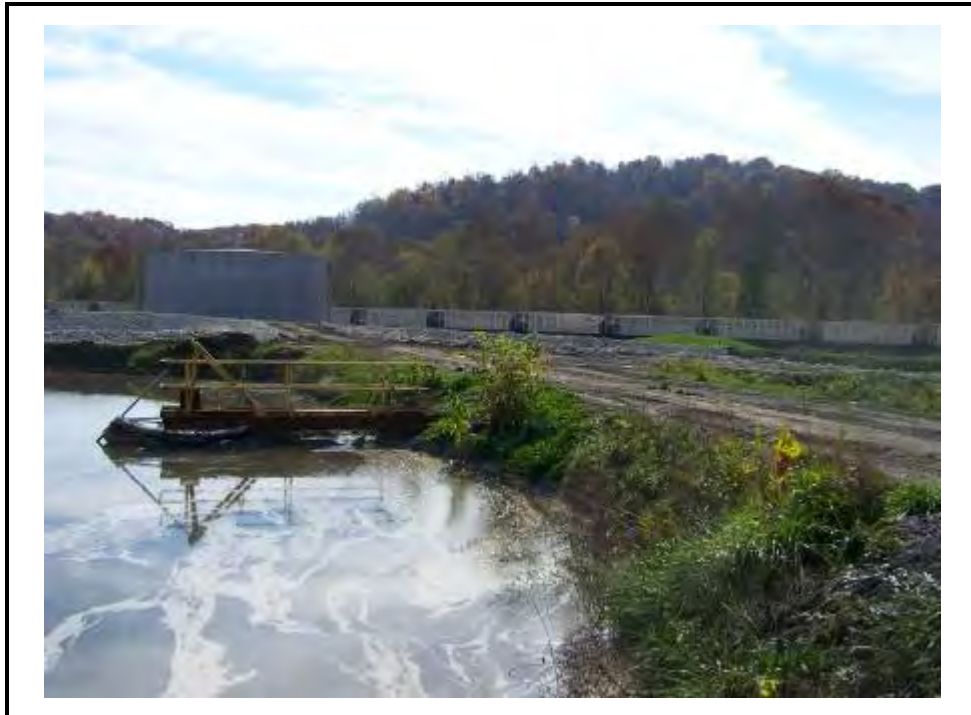
62

East slope of Splitter Dike between north Bottom Ash and Clearwater Ponds and decant structure.

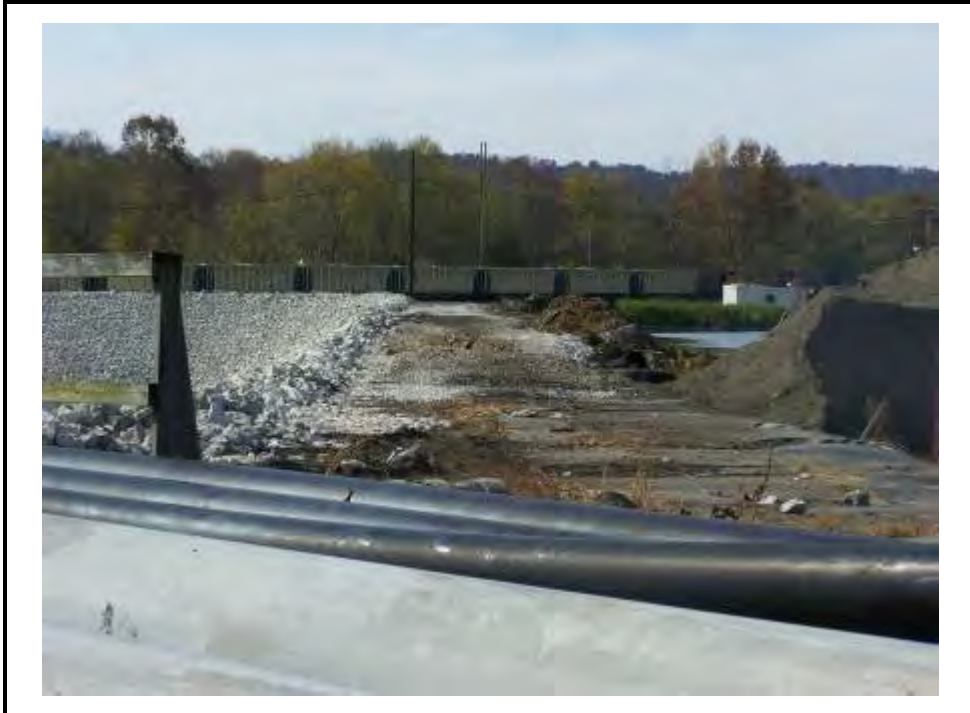
63

Crest of Splitter Dike between south Bottom Ash and south Clearwater Ponds.

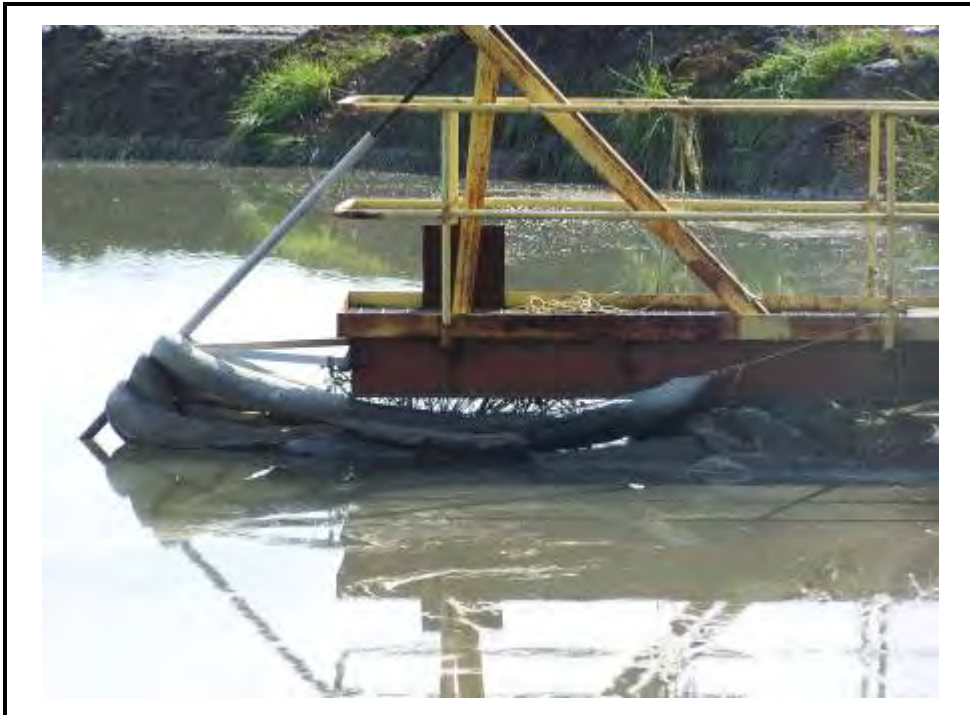
64

Close-up of decant structure in north Bottom Ash Pond.

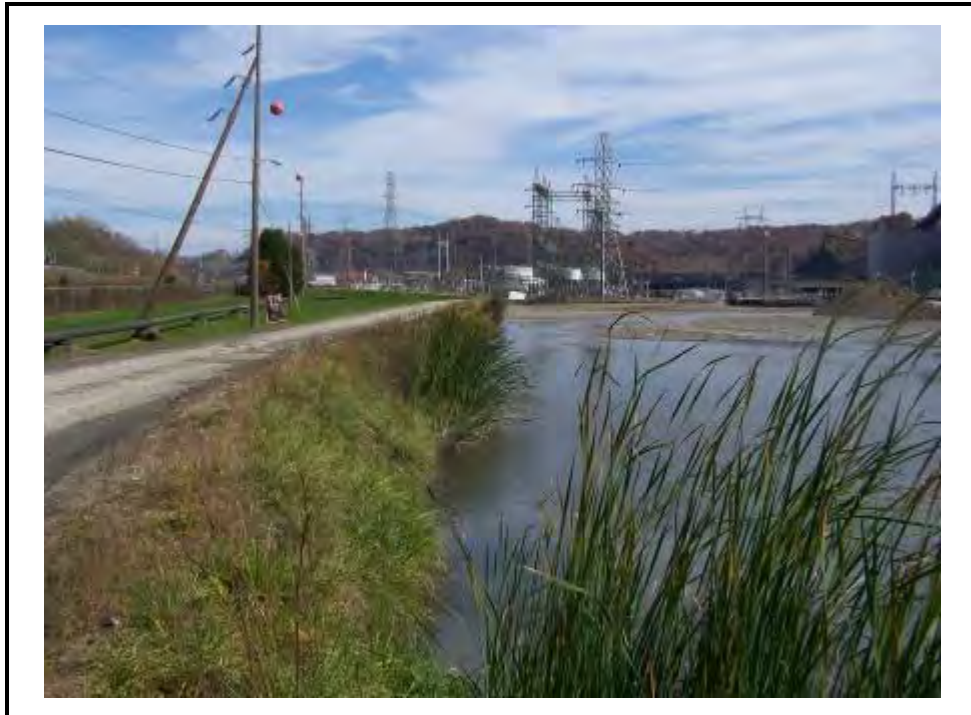
65

Upstream slope of North Dike at the Bottom Ash Complex adjacent to north Bottom Ash Pond, looking east.

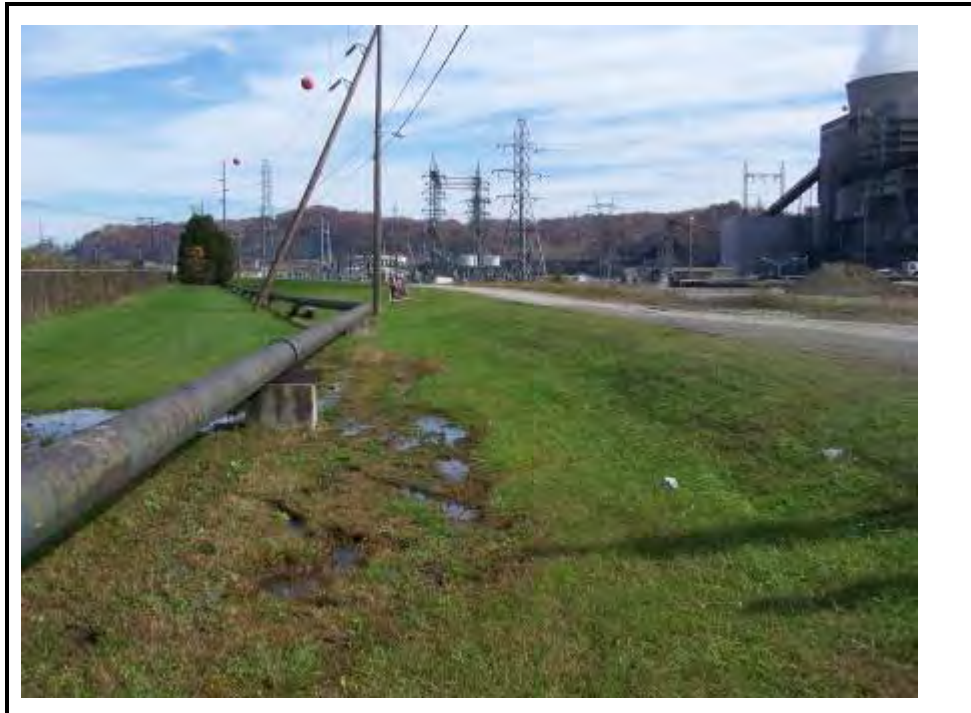
66

Downstream slope of North Dike and Bottom Ash Complex adjacent to north Bottom Ash Pond, looking east.  
Note that the north side of the Bottom Ash Complex is largely incised.

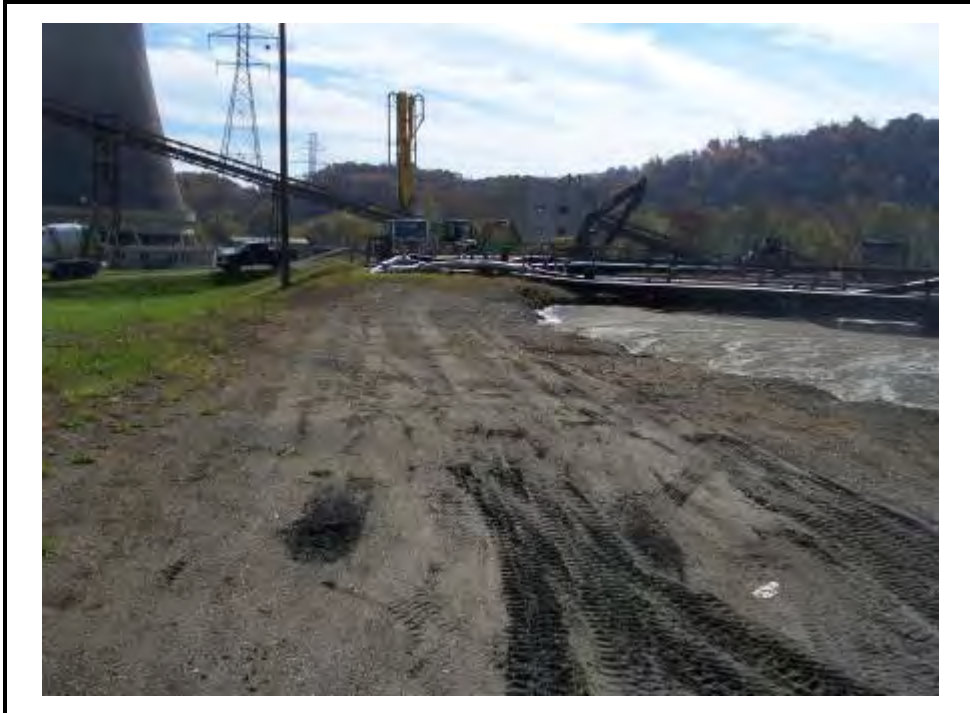
67

Crest of East Dike of the Bottom Ash Pond, looking south.

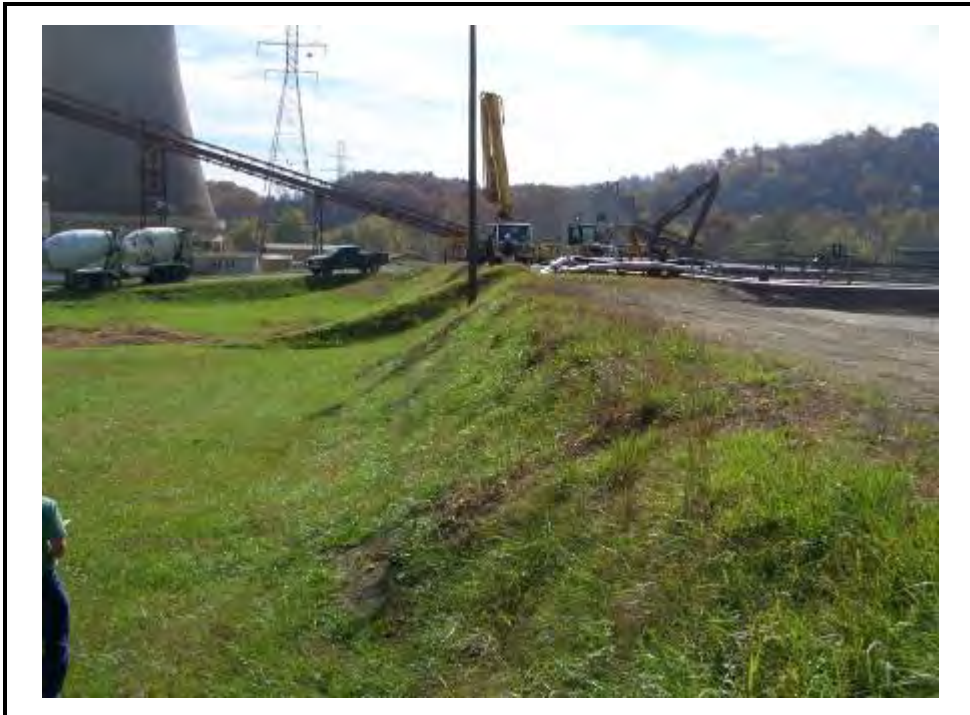
68

Downstream slope of East Dike of the Bottom Ash Pond, looking south.

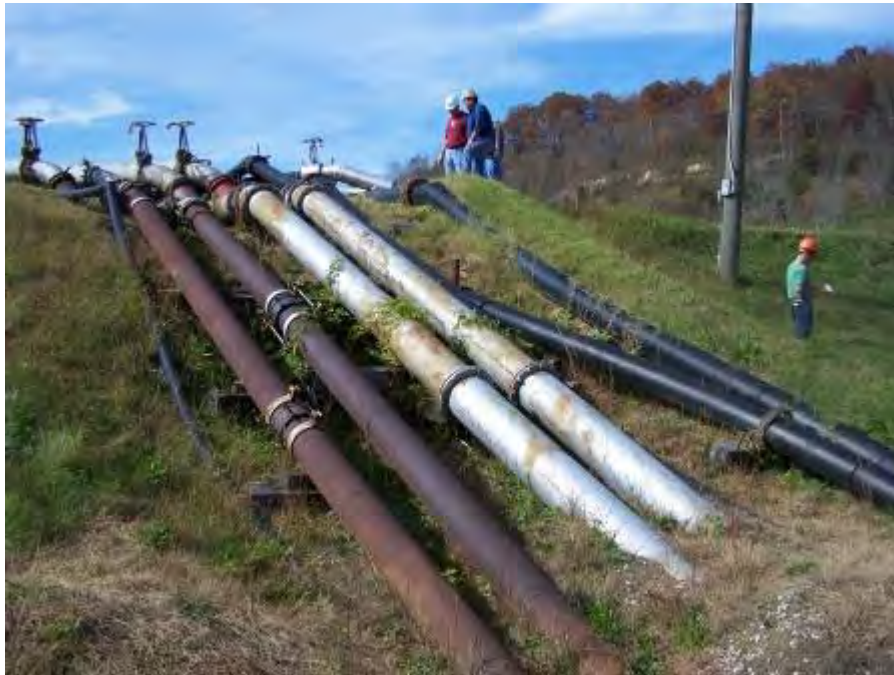
69

Sluice lines on downstream slope of East Dike.

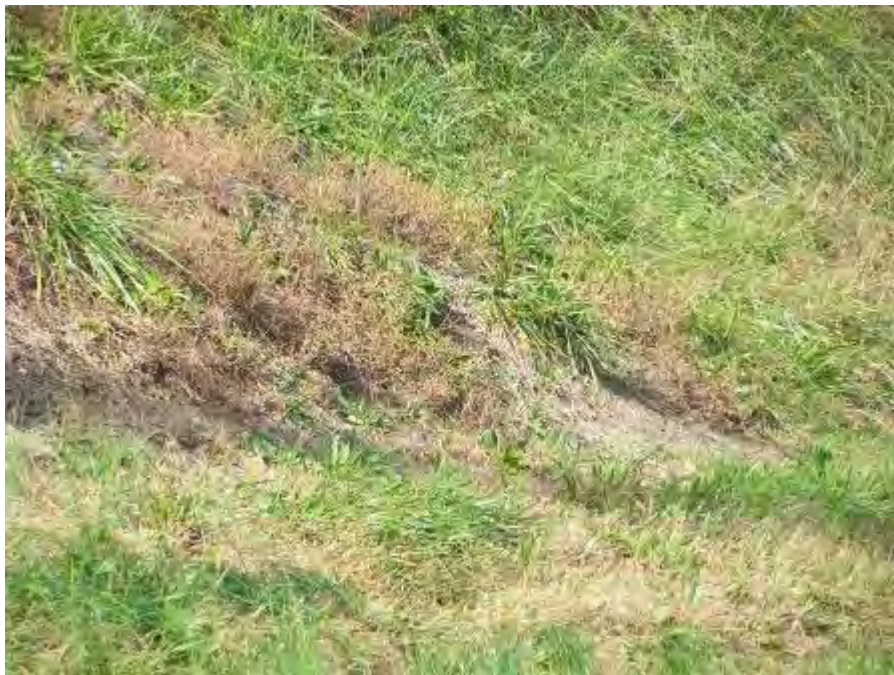
70

Minor sloughing or erosion on downstream slope of East Dike.
